# MONUMENT RECORD

Corner ID: **BeBI\_M13**

Sections 15, 16, 21 & 22- T10N-R02W, 2nd P.M.  
Bean Blossom Township, Monroe County, Indiana

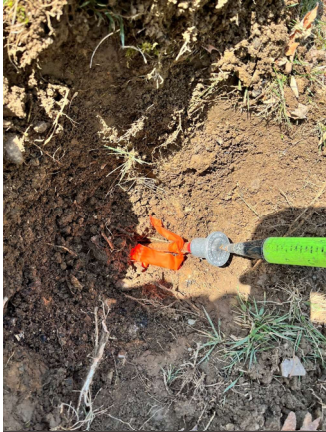
Photo Orientation & Description: From above

Date of Field work/Search: 03/26/2025 By: MES/JMG Monument Found: Bent iron pipe pulled and replaced with capped rebar. BTs or Reference Objects Found: No, but references made. Project #: 24-004 Field Book: 58 pages 4 & 5. Notes:

GPS coordinates were established on the rebar set. 2 rebar Lites were set within sight of the rebar that could be used to reestablish its location should it become obliterated. Additionally, trees and a post with Monroe County Survey marker sign was set facing south were located/set to act as visual references to aid in visually locating the rebar.

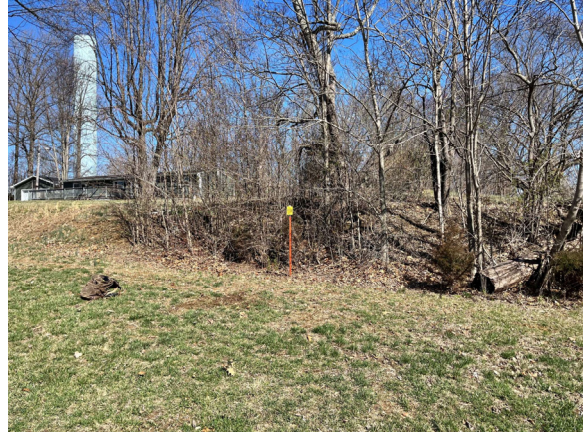
Photo Orientation & Description: From South looking North

The capped rebar is in an old grassy roadbed just west of where an asphalt road turns South. Across the road from and just Northwest of a house at 8448 North Jenner Drive Ellettsville Indiana.
